Manhole Inspection Summary

Manhole # S33EE_050MH

Insp Date: **2/26/07 1:26 PM**

Location Address: **MARTIN LUTHER KING JR BLVD**

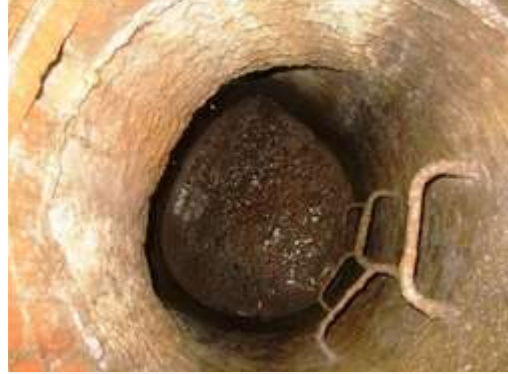
Top View

☒ **Debris** (not Condition related)

Count: **5** Missing: **0** ☒ **Corroded**

Corroded steps. Channel debris.

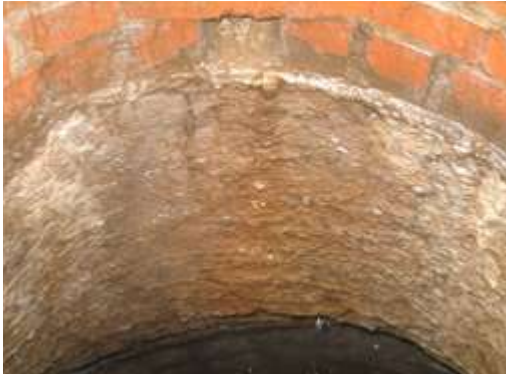
Defect

Comments **There is active infiltration in the Adjustment.**

Condition: ☐ Sound ☐ Cracked ☐ Root Intrusion ☐ Loose Brick ☒ **Deteriorated**

Infiltration: ☐ None ☒ **Joint** ☐ Cracks ☒ **Mortar** ☐ Roots ☐ Wall

Adjustment deterioration and infiltration. (Active). Mineral deposits and a missing brick.

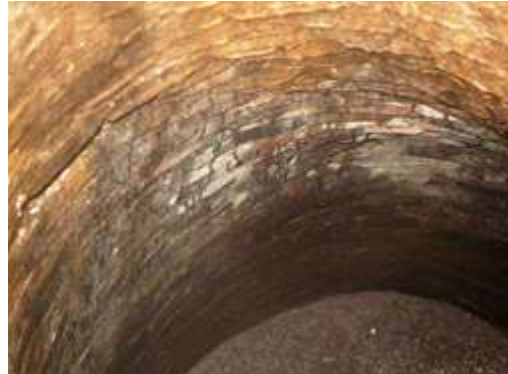
Defect

Infiltration: ☐ None ☐ Joint ☐ Cracks ☐ Mortar ☐ Roots ☒ **Wall**

Corbel and Barrel infiltration.

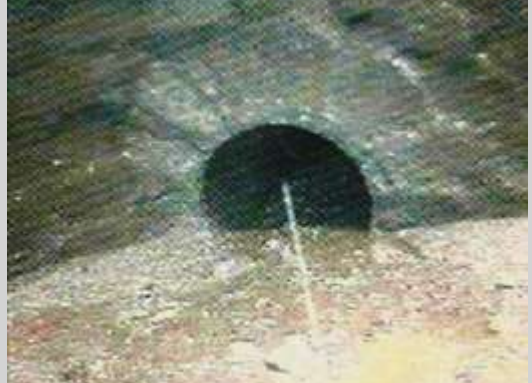
8 in. Circular Gravity Sewer
Pipe Out @ 12 O'Clock

Deposits: ☐ None ☒ **Mud** ☐ Sludge ☒ **Debris** ☐ Grease

Silt Depth: **2** (in.) Deposits Extent: **Light**
